# Prosthetic Fracture of a Cemented Exeter Femoral Stem

Facek M<sup>1</sup>, Khatib Y<sup>1</sup>, Swarts E<sup>2</sup>

We present a single case of fracture of an Exeter femoral prosthesis at the neck, occurring after a fall from standing height, in a lean 70yr lady at 6 years post implantation. The fracture propagated from the insertion dimple on the superior aspect of the prosthesis shoulder. Materials analysis suggested variance in composition of the alloy, particularly with grain size heterogeneity. Whilst Exeter femoral prosthesis fracture is extremely rare, when it does occur the literature suggests it is often in the context of excessive mechanical stresses (obesity, high offset, falls). However, this case may represent a failure of materials rather than mechanical stresses alone.

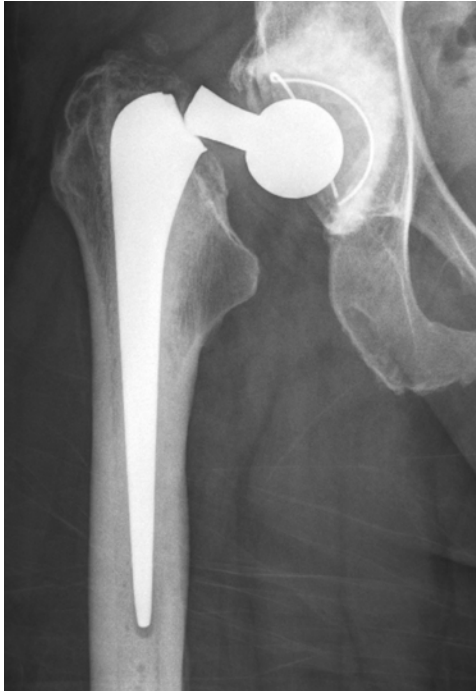
*Fig 1: Prosthetic fracture of a polished, tapered, collarless femoral stem; a cemented polyethylene cup has been used.*

In June 2015, she had a fall from standing height causing a painful right hip. Radiographic examination showed a femoral prosthetic fracture at the base of the neck of the femoral component (Fig 1).

After discussion and appropriate consent, we performed cement-in-cement revision surgery to exchange the broken femoral stem using a new Exeter femoral component. Intra-operatively, the implant appeared well-fixed without signs of loosening or infection. Positioning of the cup and stem and were appropriate, with an intact satisfactory cement mantle, although the shoulder of the stem was proud of the level of femoral osteotomy by 10mm.

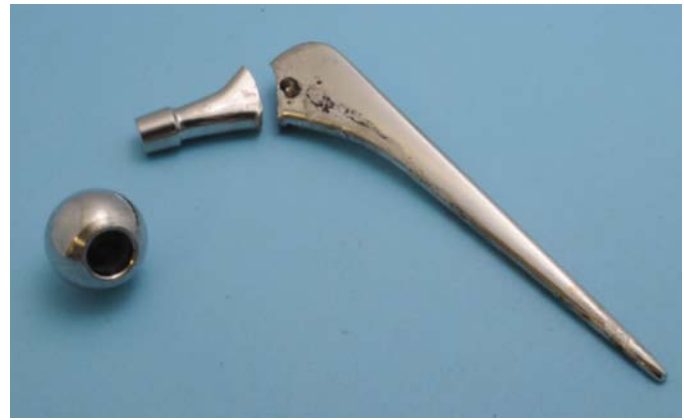
The stem fracture had initiated from the insertion guide 'dimple', at the point of its maximum diameter, and propagated transversely (Fig 2). The proximal neck fragment and taper well were engaged with the femoral head, and in turn were located in the acetabular component. The acetabular component had an intact rim with no signs of neck impingement and no evidence of eccentric wear of the cup.

*Fig 2: The prosthetic stem fracture propagated inferiorly from its origin at the insertion "dimple".*

SEM of the fracture surface revealed dimple rupture, cracking, beach marks and some areas showing fatigue striations, common to a fatigue failure. Apart from the insertion guide hole, no other obvious stress risers were detected near the crack initiation zone. The fracture initiated at the anterosuperior edge of the stem in close proximity to the stem insertion guide hole. Lack of proximal bone or cement support at this region can result in increased bending forces.

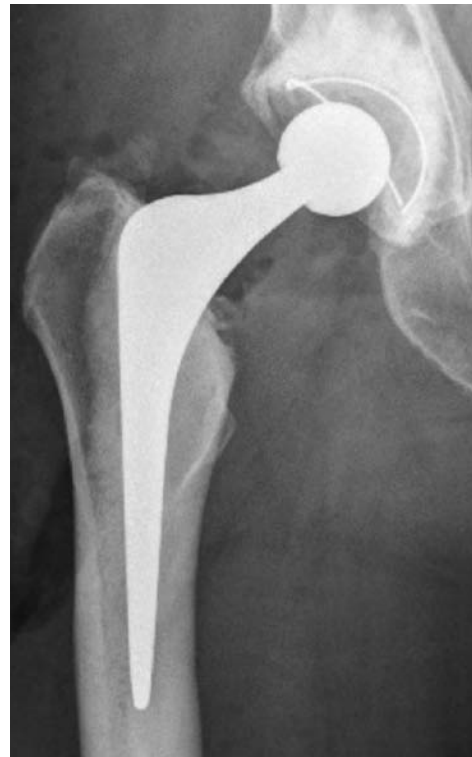
*Fig 3: Successful cement-in-cement technique using smaller sized stem.*

lizing the previous posterior approach and a cement-in-cement revision technique. The stem was removed without damaging the cement mantle, and a smaller stem of the same design (Exeter 44mm No.00) designed for the use in cement-in-cement revisions was used. The cement cavity was cleaned and thoroughly dried, and the new stem installed using cement within the existing mantle with a hollow centraliser (Fig 3). The surgical procedure proceeded successfully and the patient made an uneventful recovery. She was allowed to mobilise full weight bearing on day one and received rehabilitation with physiotherapy prior to discharge 6 days after surgery. Our patient received routine post-operative follow up and reported good function with Oxford Hip Score 37, 12-months after her revision surgery.

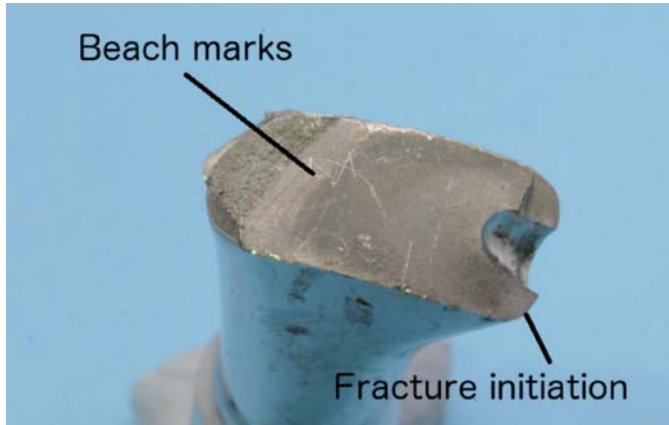
Retrieval analysis of the fractured Exeter components was performed. Macroscopically, “beach marks” were seen across the fractured surface, a sign of chronic material fatigue (Fig 4). Evidence of corrosion was detected

Fig 4: Concentric “beach marks” seen at the fracture plane, an indication of material fatigue; they represent successive arrests or decreases in the rate of fatigue crack growth due changes in material loading over time. This pattern indicates rapid progression from the initiation site, and slower progression where the beach marks are seen.

Beach marks and fatigue striations noted on the fracture surface in our case indicate a fatigue mode of failure. Variation in microstructure, as well as hardness, suggest alloy segregation. Large grains near the surface are most likely a form of secondary recrystallization as a result of heat treatment. These are significant factors that can predispose the stem to failure. Unfortunately this is not an isolated case and we have observed grain size and hardness variation on five previous Exeter stem fractures. [5] Only the manganese and nitrogen concentration slightly exceeded the compositional limits outlined in ISO 5832-9. These are only minor non-conformances and would not be expected to have any influence in stem failure. Other clinical factors that may have contributed to failure include: patient fall, medium to high activity level and femoral canal morphology.

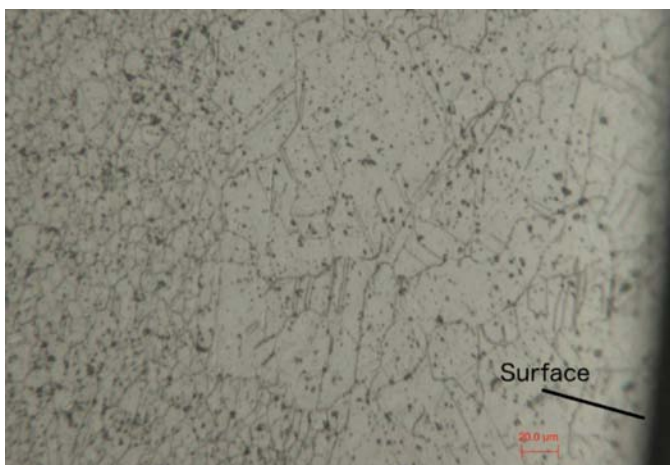
along the medial edge and posterior surface of the stem, with minor corrosion in the trunion and no evidence of corrosion on the neck. The stem exhibited heterogeneity of microstructure; specifically, there was a high proportion of large grains near the prosthesis surface, which can be observed when an alloy has re-crystallized after heat-treatment, whereas the rest of the stem was fine-grain austenite (Fig. 5). This variance in composition has been noted in previous prosthesis retrieval analysis [5] which showed that coarse grain size, and grain heterogeneity, were consistent with lower fatigue and yield strengths.

Fig 5: Variability in grain microstructure between surface region (right side) and central portion (left side) of prosthesis seen on this high power view.

Chemical analysis of the stem composition was undertaken with SpectroMaxx Optical Emission Spectroscopy (OES) to verify composition; there were minor, non-significant aberrations in manganese and nitrogen, but no evidence of abnormalities to account for fracture (Table 1). More significant was variability of microhardness with distinct hardness difference according to grain size. The average hardness of large grains was 292 Hv, while average hardness of small grains was 362 Hv.
