The 16-Year Evolution of Proximal Modular Stem Design – Eliminating Failure of Modular Junction

Tkach T¹, McTighe T²

Abstract

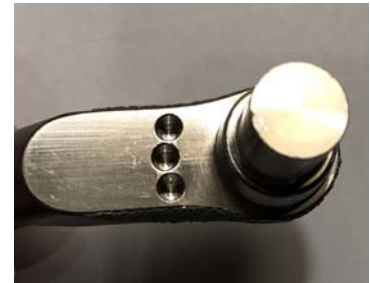
gle. The diameter of the locating pin was 3.175 mm and would engage with one of three holes within the interface of the modular shoulder/neck. This provided 13° of version control. One of three positions could be picked, 13° of anteversion, neutral, or 13° of retroversion. Figure 5A & B.

Figure 5B. Underside of neck showing 3 pin holes for version angle. (Courtesy JISRF Archives)

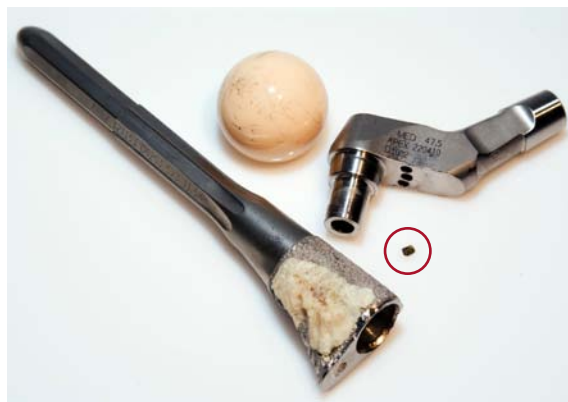
is easily generated. You might also think the fractured location/ de-rotation pin was a fatigue failure problem. This was also not the case. Figures 8, 9A, B, & C.

Figure 8. Retrieved Apex Modular Stem showing broken locating pin with no other apparent damage to Dual Press Modular Junction. Note: Good bone attachment to porous surface. (Courtesy JISRF Archives)

Upon inspection of the retrieved fractured pins (c.c.) there was no evidence of a fatigue failure [11]. So what was the cause of the fracture? The hypothesis is a dynamic high impact torsional shear failure marked by a vigorous physical force applying a load well beyond the shear strength of the material. Another way of expressing this would be a moment of momentum that produces a load beyond the shear strength of the material. Example jumping off the bed of a pick-up truck landing with your foot internally rotated or possibly stumbling could generate a high dynamic impact torsional load resulting in a shear failure of the locating/de-rotational pin.

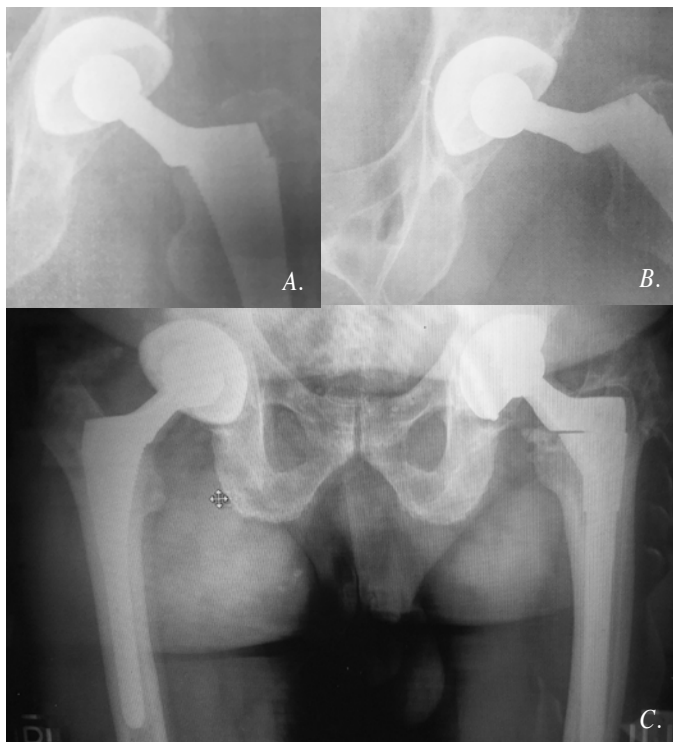
sense of hip instability, progressing to a painful hip. Lateral X-Ray views would demonstrate the implants to be rotated out of position and on rare occasion totally disengage from the Dual Press modular junction. Revision of the failed implant is not overly difficult. The proximal neck can be removed by hand providing direct access to the stem body. Retrieval instruments allowed for firm attachment and with the help of flexible osteotomes or a small high-speed burr you can break the bony attachment with minimal bone destruction. Often femoral replacement can be done with a primary length stem. Figures 7A, B, & C.

Figures 7A, B, and C. A: Post-op A/P X-ray of a fractured locating/de-rotational pin. Note: is difficult to appreciate the pin has been broken on this view. B: Lateral X-Ray demonstrating modular shoulder/neck component has rotated out of position of function. C: A/P x-ray showing bi-lateral hips with Apex Modular stem on the left side, and a S-Rom (primary stem-length) that replaced the fractured locating/de-rotational pin on the right. (Courtesy T. Tkach)

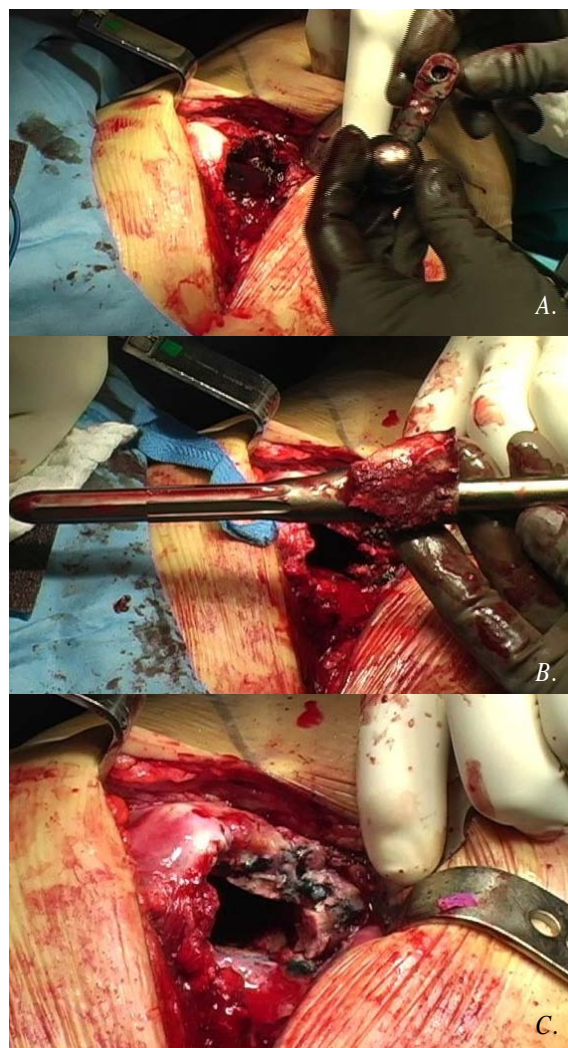
Since the two modular pieces are titanium there often would be considerable black debris and staining of the tissues making one think of corrosion. This was not the case. Titanium is a relatively soft material and abrasion debris

Figures 9A, B, and C. A: Picture showing proximal modular shoulder/neck with femoral head attached. B: Showing stem removed with significant bone attached to proximal porous area with retrieval instrument attached C: Showing stem removed with black titanium debris. Note: this is not corrosion (Courtesy JISRF Archives).

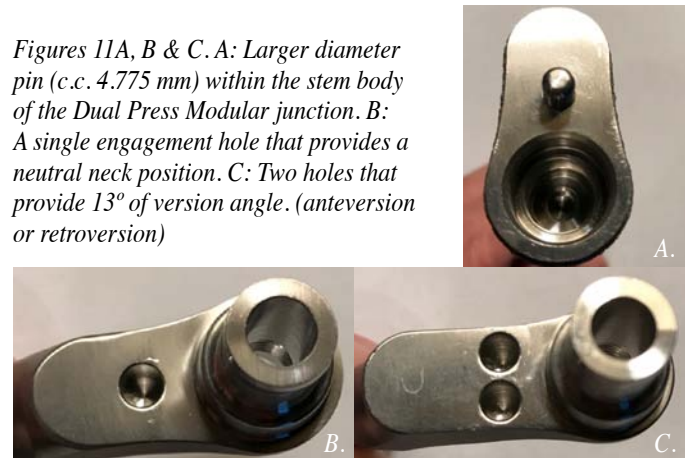
The Omni Mod Stem design is the exact same features of the proximal shoulder / neck and the stem body from Gen I with changes to the structures within the Dual Modular junction (plug to bolt and diameter of locating pin from 3.175 mm to 4.775 mm). The dimensions for the two bands of interference fit remained the same.

The increase in pin diameter resulted in creating two different shoulder / neck configurations. One style has a single engagement hole for neutral version and a second style that has two holes for selection of anteversion or retroversion at 13°. (Figure 11A, B, & C)

Figures 11A, B & C. A: Larger diameter pin (c.c. 4.775 mm) within the stem body of the Dual Press Modular junction. B: A single engagement hole that provides a neutral neck position. C: Two holes that provide 13° of version angle. (anteversion or retroversion)

This corrective action resulted in 225% increase in torsional strength. It serves as an example that changes and improvements are possible once there is a full understanding of the problem. There have been no reported mechanical failures of its modular junction since 2004 with the improved design “Omni MOD Stem” (Figure 12). [13]
